# **EXPERT REPORT OF DAVID CROWE (Bellwether 3)**

*In re* Flint Water Cases,  
*U.S. District Court for the Eastern District of Michigan*  
Civil Action No.5:16-cv-10444-JEL-MKM  
(consolidated docket)

*Walters, et al. v. Snyder, et al.*, Civil Action No.5: 17-cv-10164-JEL-MKM  
“Bellwether 3 Trial”

July 26, 2023

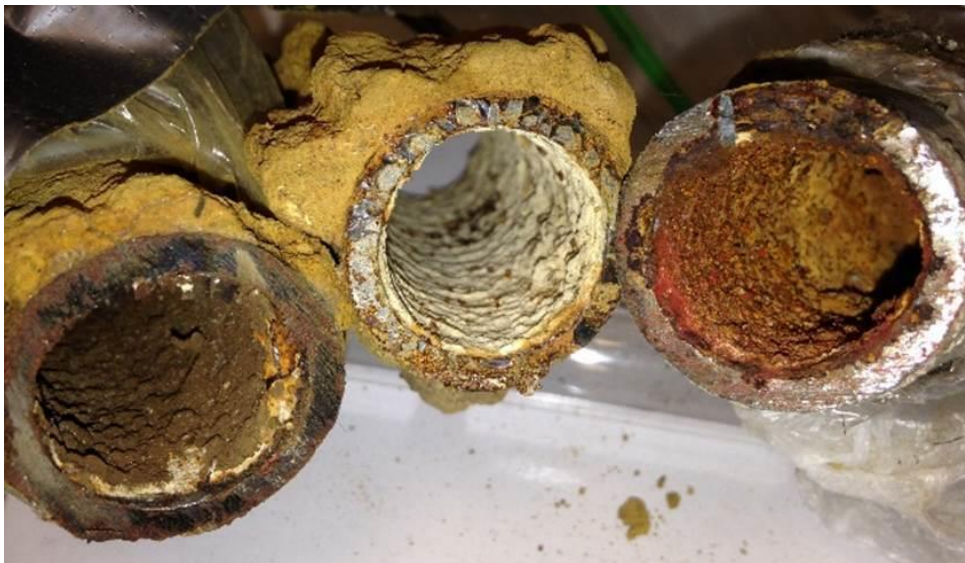
Scale in Flint pipes is illustrated in **Figure 1**, which shows scale and rust inside what appears to be steel piping. This scale would have been altered during the water crisis, but the extent of loss or thinning of the scale or the underlying pipe wall is an open question. The EPA recognized that the lead release in Flint was coming from damaged scales in lead pipes (3). Testing of corrosion in circulating pipe loops used sections of lead pipe with intact scales (3). If scales remained on the lead pipe, they would have remained on all the piping. This is the condition of pipes that existed in Flint during and after the Flint River water period in 2014-2015. The pipes were lined with scale that protected them from corrosion.

**Figure 1.** “Different kinds of iron corrosion and rust were found in Flint drinking water pipes. Photo credit: Min Tang and Kelsey Pieper, Flintwaterstudy.org” (9). The pipes appear to be steel.

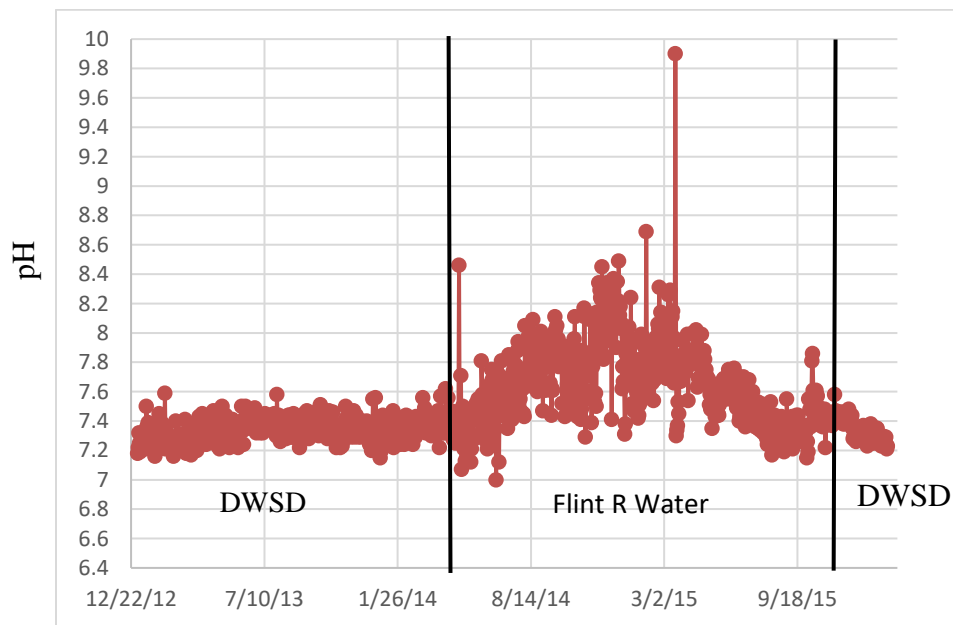
**Figure 2.** Measured pH from January 2013 to February 2016. The vertical black lines mark the period of use of Flint River water from May 1, 2014 to October 17, 2015.

Uniform corrosion of copper, as distinct from pitting, is favored in waters with low pH and high alkalinity (17). Copper corrosion is known to increase as pH decreases below 6. There is no record of Flint water pH falling below 7, **Figure 2**.

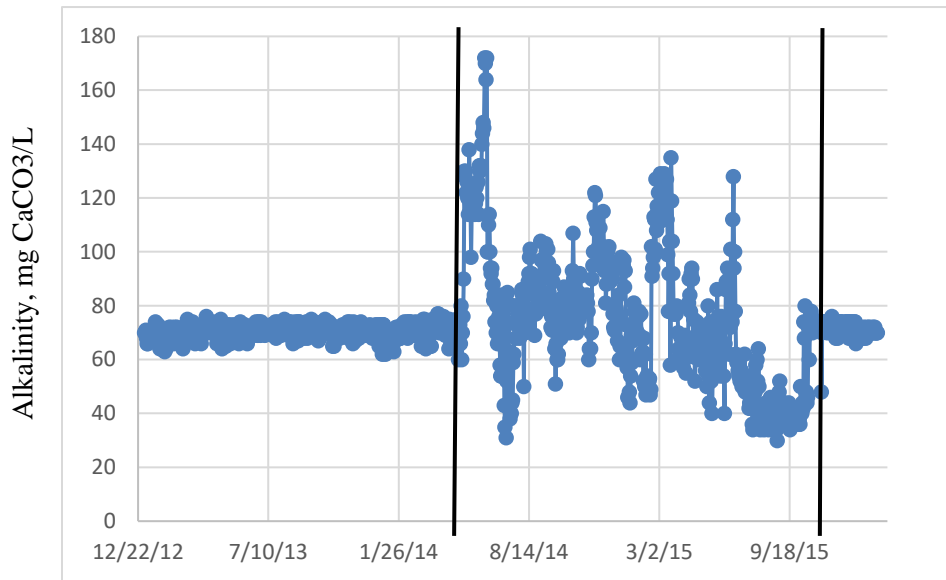
It is believed that the scale observed on the copper pipe was not disturbed during the Flint River water exposure, and that this scale would have protected the copper from corrosion. In case there were areas of the pipe where the scale was removed by some means, say erosion, then some corrosion may have occurred. An estimate of changes in copper solubility was calculated to understand the effect of the changes in chemistry during the Flint River water exposure. Data from the Flint Water Plant were entered into a spreadsheet and are plotted below. The data on pH and alkalinity have been plotted in **Fig. 2 and 3**. It can be noted that the pH increased during the use of Flint River water, and that the alkalinity was mostly higher, but with periodic decreases below 60 mg CaCO<sub>3</sub>/L and a couple of extended periods below 40 mg CaCO<sub>3</sub>/L.

**Figure 3.** Measured alkalinity from January 2013 to February 2016.
